MILLIS MIDDLE HIGH SCHOOL Roof and HVAC Feasibility Study Millis, MA

Prepared For:
Millis Public Schools
245 Plain Street
Millis, Massachusetts 02054

CBI Consulting LLC.
250 Dorchester Avenue
Boston, Massachusetts 02127
CBI Project No. CB192030

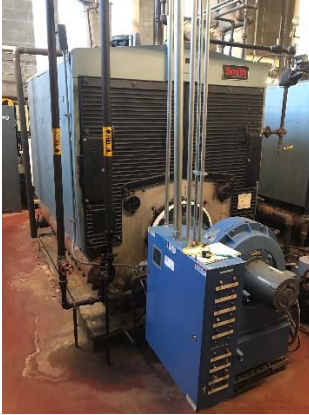
Typical Hot Water Boiler

The building is heater with (3) hot water boilers (Smith model # MB99032) with a heating capacity of 5,856 MBH each. The boilers operating efficiency is approximately 80%. The boiler burners are dual fuel type and can operate with natural gas and fuel oil. Fuel oil is provided from an exterior fuel oil tank, fuel oil pumps and fuel oil piping. The boilers and fuel oil systems appears to have been installed in 1996 and more than 20 years old.

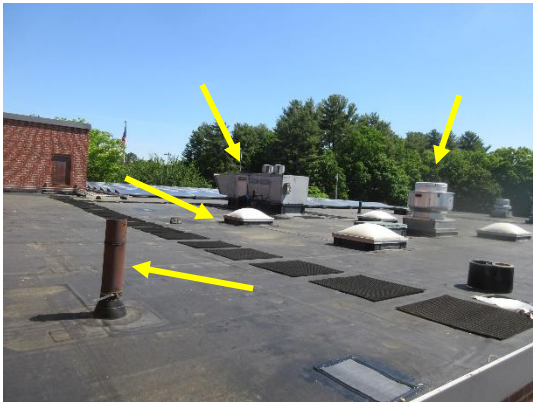
<p>Typical view of rooftop mechanical equipment, skylights and rust corroded vent stack piping.</p>

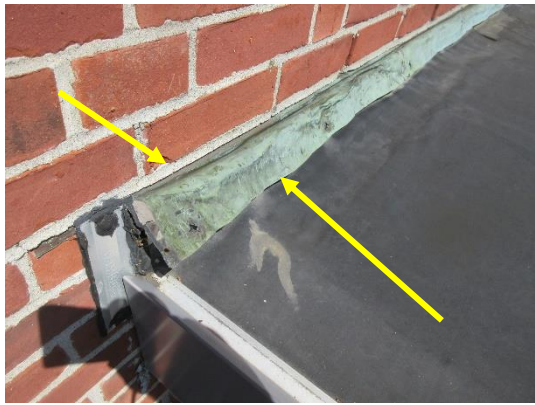
<p>View of existing copper through-wall flashing. Notice the low height of the flashing and damaged conditions, and deteriorated sealant. This condition typical on all roof areas that include through-wall flashing.</p>
5

Other associated work would include, select gypsum deck repairs, raising of through-wall flashings at higher brick masonry walls, restoration of the large brick masonry chimney, all new perimeter wood blocking and edge metal systems, replacement of sealants at windows, doors and louvers directly above roof areas, unit skylight replacement, roof access hatch replacement and roof drain replacement. We also suggest painting of corroded vent plumbing stacks and access doors.

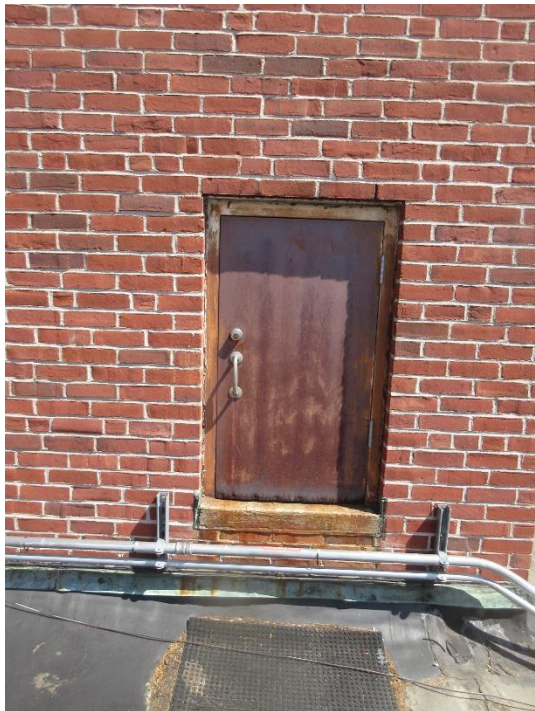
<p>View of rust corroded access door.</p>

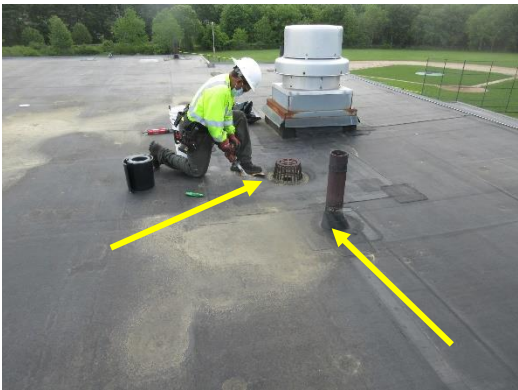
Roofing test cut in progress, notice rust corroded vent pipe and roof drain.

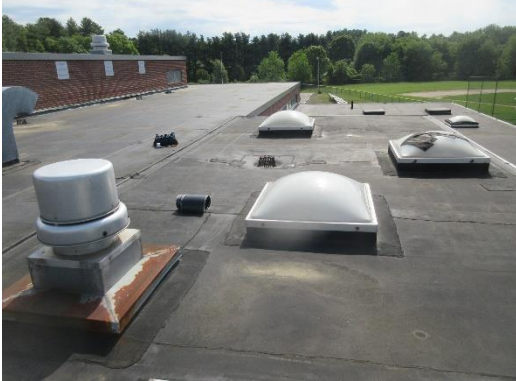
A closer view of the roof surface. It shows several skylights, a roof drain, and a large white cylindrical exhaust fan. One skylight dome is broken and sealed with membrane flashing. The background shows a green field and trees.	Another view of Roof Area D, containing skylights, roof drain and exhaust fan. Notice the broken skylight dome sealed with membrane flashing.

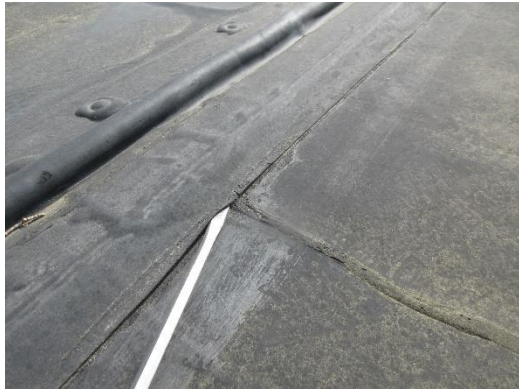
View of open membrane lap seam at expansion joint.
3

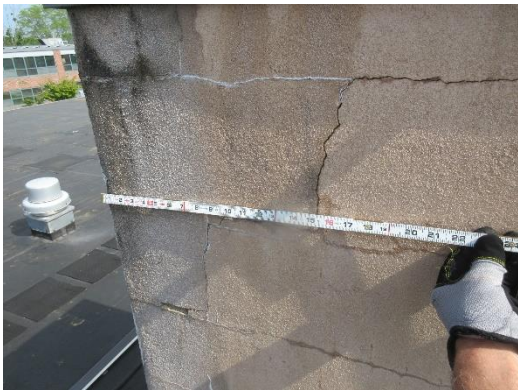
View of cracked and deteriorated stucco on Elevator override.

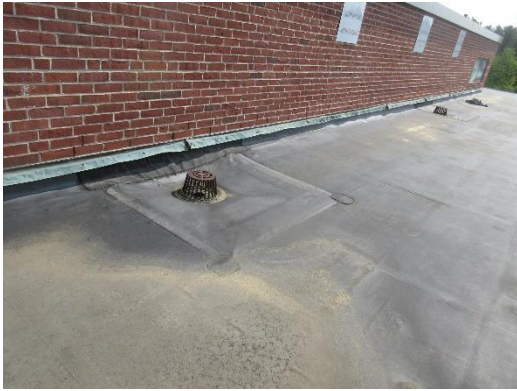
<p>View of existing copper through-wall flashing. Notice the low height of the flashing and damaged conditions, and deteriorated sealant. This condition typical on all roof areas that include through-wall flashing.</p>
<p>6</p>

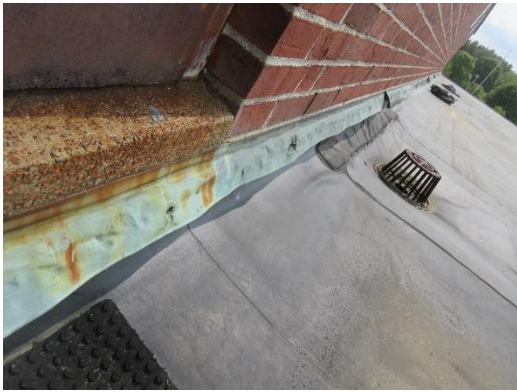
<p>View of existing copper through-wall flashing. Notice the low height of the flashing and damaged conditions, and deteriorated sealant. This condition typical on all roof areas that include through-wall flashing.</p>
<p>7</p>

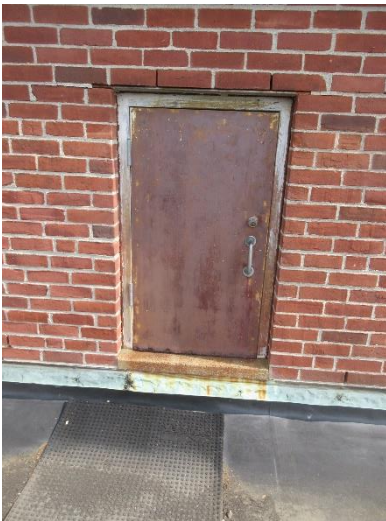
<p>View of rust corroded access door.</p>

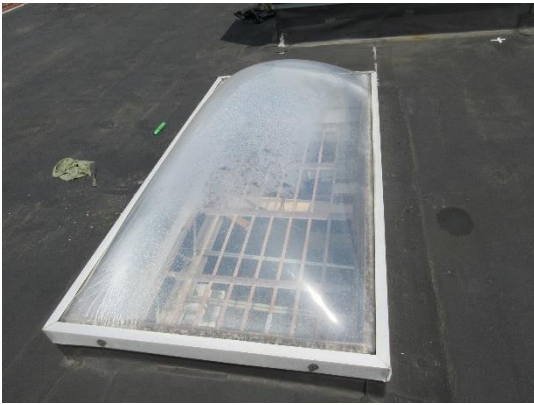
View of skylight. The polycarbonate dome is checked, an cracked, with condensation on the interior surface.
3

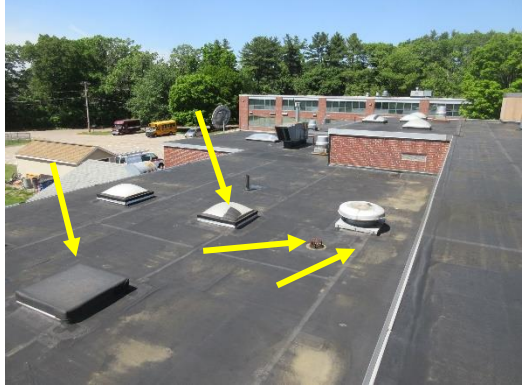
Overall view of Roof Area D.1, including skylights, exhaust fan, covered abandoned curb, and rust corroded roof drain. Notice the broken skylight dome sealed with membrane flashing.

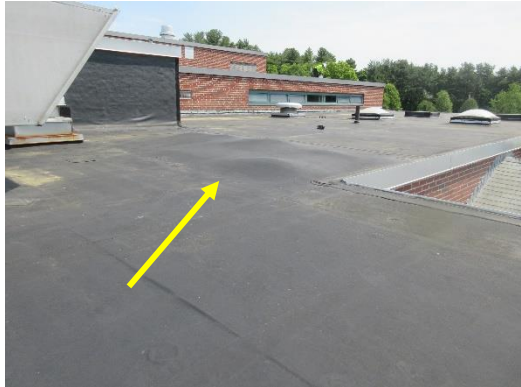
A wide-angle photograph of a flat roof. A yellow arrow points to a large, dark, irregularly shaped area on the roof surface, indicating buckled roofing insulation. In the background, a brick building with a large garage door is visible under a clear sky.	<p>View of severely buckled roofing insulation below the membrane surface.</p>
5

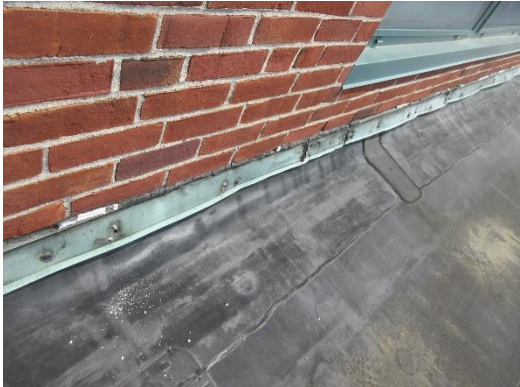
A close-up photograph of a brick wall meeting a roof. A piece of copper flashing is installed at the junction. The flashing is low and shows signs of wear and damage. The roof surface below is dark and appears to be made of asphalt or a similar material.	<p>View of existing copper through-wall flashing. Notice the low height of the flashing and damaged conditions, and deteriorated sealant. This condition typical on all roof areas that include through-wall flashing.</p>
6

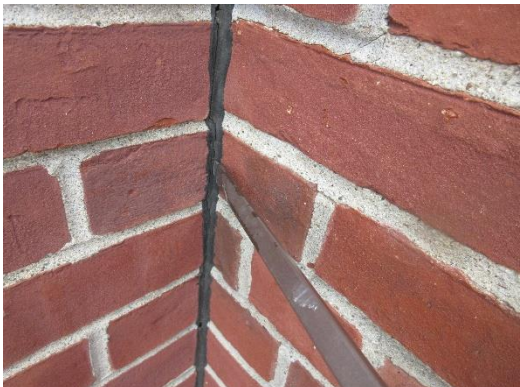
A close-up photograph of a corner where two brick walls meet. A dark sealant is applied in the joint between the bricks. The sealant appears to be cracked and deteriorated, with some loss of material.	<p>View of sealant at adjoining brick masonry wall. The sealant was deteriorated, and included cohesive and adhesive failures.</p>

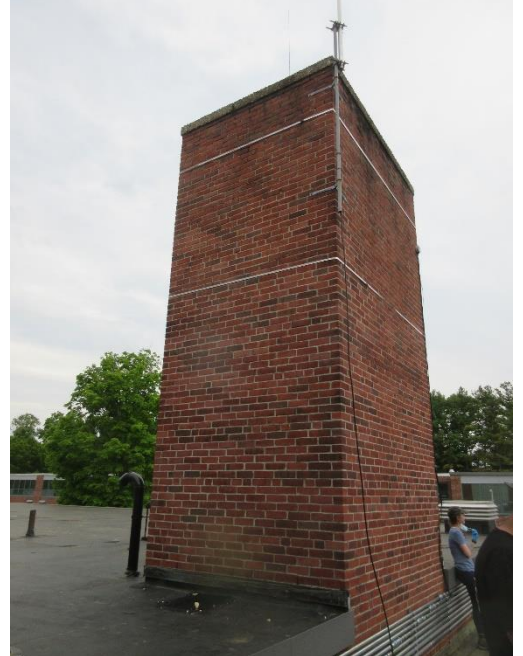
View of brick masonry chimney.
6

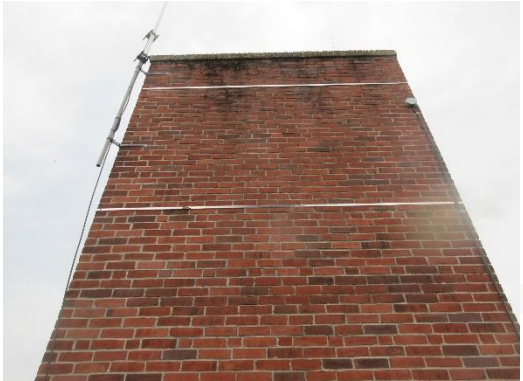
The brick masonry chimney includes, cracked, debonded and eroded mortar joints, and random cracked brick.

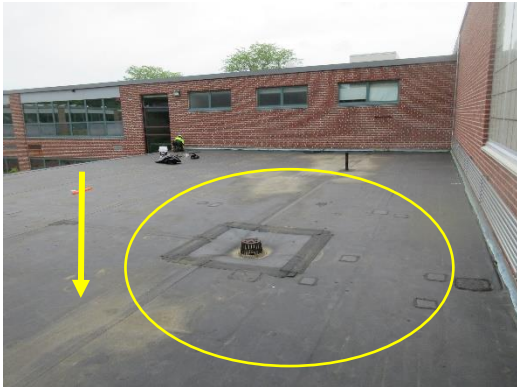
Another partial view of Roof Area F. Notice the remanence of ponding water with dirt residue and repair patches.

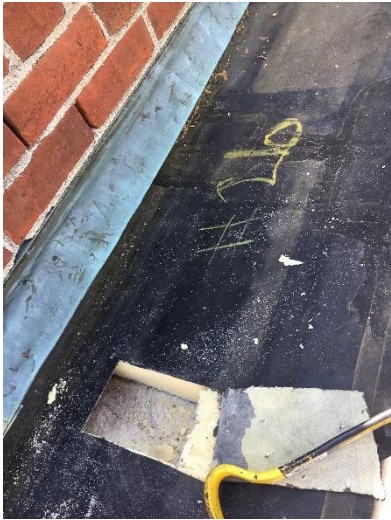
<p>View of existing copper through-wall flashing. Notice the low height of the flashing and damaged conditions, and deteriorated sealant. This condition typical on all roof areas that include through-wall flashing.</p>
<p>6</p>

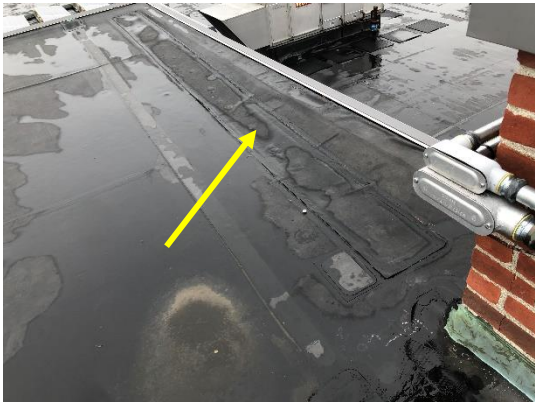
<p>View of repair patch, which includes curled and open lap seams.</p>

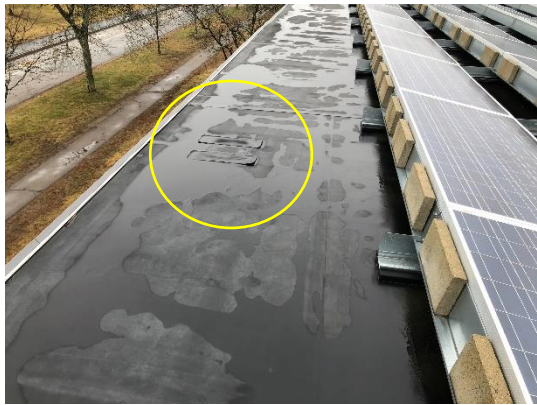
<p>View of repair patches, which includes curled and open lap seams.</p>
<p>9</p>

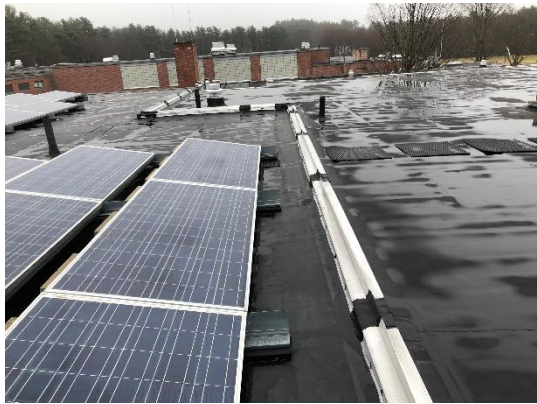
<p>View of building expansion joint between Roof Area G and H. Notice the joints are covered EPDM membrane seam tape. The joint is also been damaged likely through the years from roof foot traffic on the roof and other activity.</p>

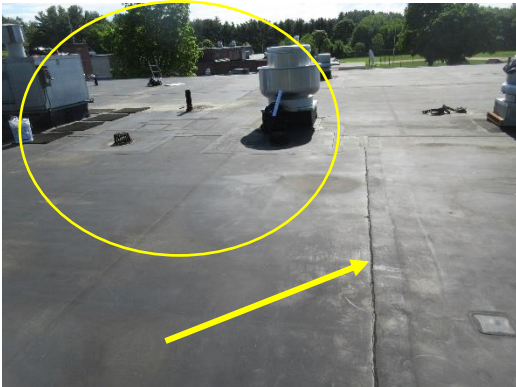
<p>View are between RTU and exhaust fan, where prior repairs were evident. Also, notice the EPDM membrane field seam, which was adhered with adhesive glue and sealant.</p>
