MILLIS MIDDLE HIGH SCHOOL Roof and HVAC Feasibility Study Millis, MA

Prepared For:
Millis Public Schools
245 Plain Street
Millis, Massachusetts 02054

CBI Consulting LLC.
250 Dorchester Avenue
Boston, Massachusetts 02127
CBI Project No. CB192030

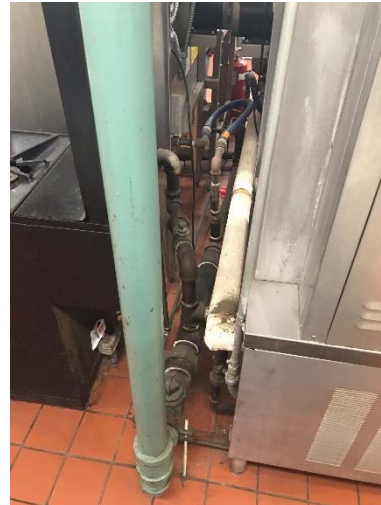
Natural Gas Pipe to Kitchen Appliances

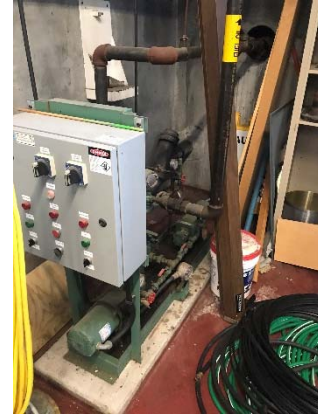
Fuel Oil Pump

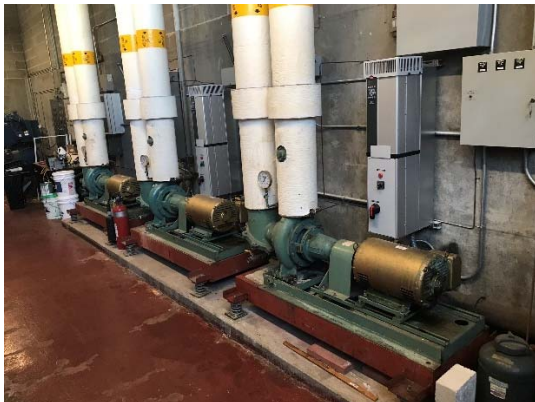
Hot water is circulated throughout the building with a hot water supply and return piping distribution system and hot water system specialties including air separator and expansion tanks. Water is pumped through the piping systems with (3) base mounted pumps each rated for 420 GPM @ 90 feet of head pressure. The pumps, water specialties and piping appear to have been installed in 1996 and more than 20 years old.

Typical Hot Water Pumps

The existing mechanical systems are in excess of 20 years old and at the end of their useful life expectancy. Replacement of these systems is recommended. These include but may not be limited to hot water boiler, pumps, water specialties, controls, unit ventilators, exhaust blowers, cabinet unit heaters, rooftop units, air handling and exhaust fans. These replacements shall be considered MEP Option 1.

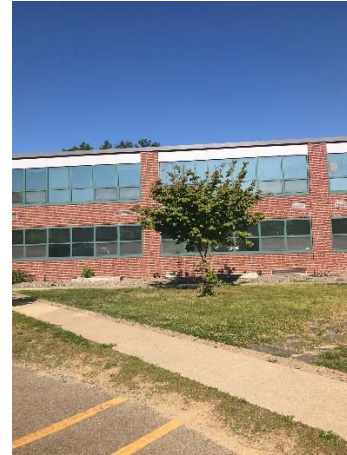
Typical Wall Louvers – Fresh Air and Exhaust Air

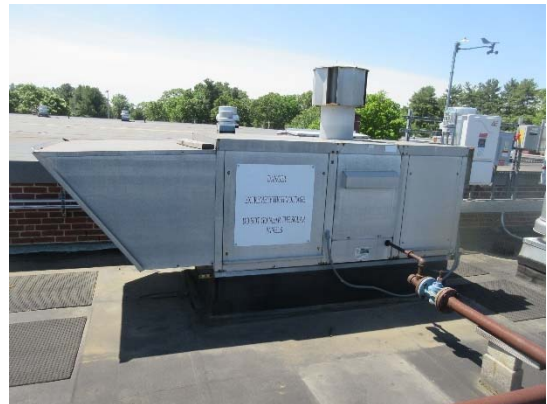
Common space and office areas are heated with finned tube radiation and cover. Each piece of finned tube is controller with a pneumatic hot water control valve and space thermostat. Ventilation air is provided through a roof mounted ventilation air unit with gas fired furnace. Ventilation air is distributed throughout the common areas and office areas with a supply air duct systems and air outlets. The finned tube radiation and ventilation systems appear to have been installed in 1996 and more than 20 years old.

Typical Ventilation Roof Top Unit

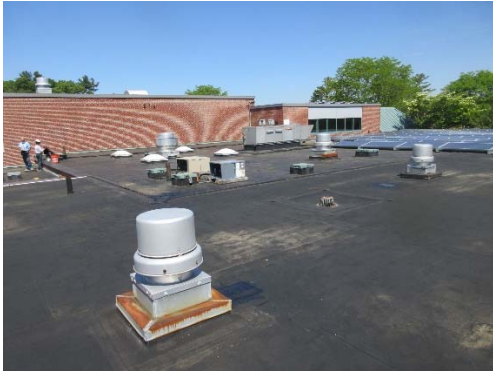
Bathroom and locker room exhaust is through roof mounted exhaust fans. Exhaust ductwork extends from the roof fan and extends to each bathroom and locker rooms and terminates with an exhaust register. Kitchen hood exhaust is through a roof mounted up-blast exhaust fan. Grease exhaust ductwork extends from the fan and extends down to hood.

Typical Exhaust Fan
