MILLIS MIDDLE HIGH SCHOOL Roof and HVAC Feasibility Study Millis, MA

Prepared For:
Millis Public Schools
245 Plain Street
Millis, Massachusetts 02054

CBI Consulting LLC.
250 Dorchester Avenue
Boston, Massachusetts 02127
CBI Project No. CB192030

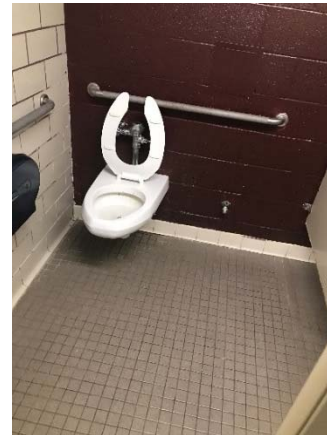
Typical Fixtures

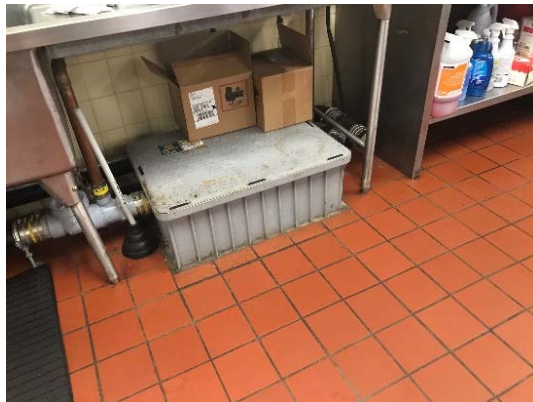
Kitchen grease interceptor is located within the kitchen below the kitchen pot sink.

Grease Interceptor

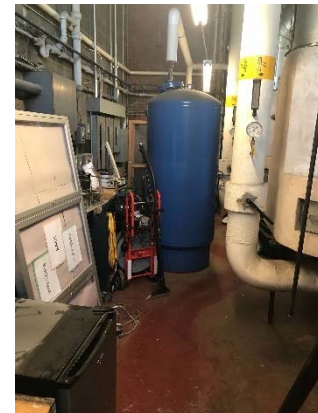
Hot water is circulated throughout the building with a hot water supply and return piping distribution system and hot water system specialties including air separator and expansion tanks. Water is pumped through the piping systems with (3) base mounted pumps each rated for 420 GPM @ 90 feet of head pressure. The pumps, water specialties and piping appear to have been installed in 1996 and more than 20 years old.

Expansion Tank

The existing mechanical systems are in excess of 20 years old and at the end of their useful life expectancy. Replacement of these systems is recommended. These include but may not be limited to hot water boiler, pumps, water specialties, controls, unit ventilators, exhaust blowers, cabinet unit heaters, rooftop units, air handling and exhaust fans. These replacements shall be considered MEP Option 1.

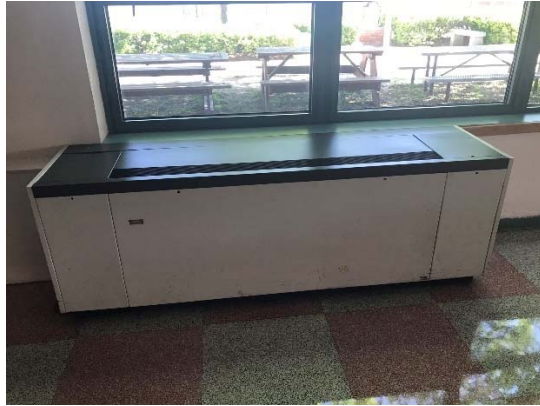
Classrooms are heated and ventilated with wall mounted unit ventilators with hot water heating coils. Exhaust is provided in each classroom through a wall mounted exhaust fan. Ventilation air and exhaust air is provided through a side wall louver and a ducted wall sleeve extends from the exterior wall to each until ventilator or exhaust fan. The unit ventilators and exhaust fans appear to have been installed in 1996 and more than 20 years old.

Typical Unit Ventilator

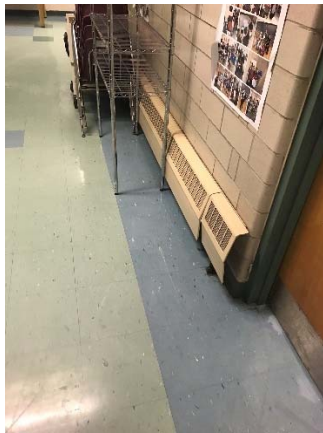
Common space and office areas are heated with finned tube radiation and cover. Each piece of finned tube is controller with a pneumatic hot water control valve and space thermostat. Ventilation air is provided through a roof mounted ventilation air unit with gas fired furnace. Ventilation air is distributed throughout the common areas and office areas with a supply air duct systems and air outlets. The finned tube radiation and ventilation systems appear to have been installed in 1996 and more than 20 years old.

Typical Finned Tube Radiation

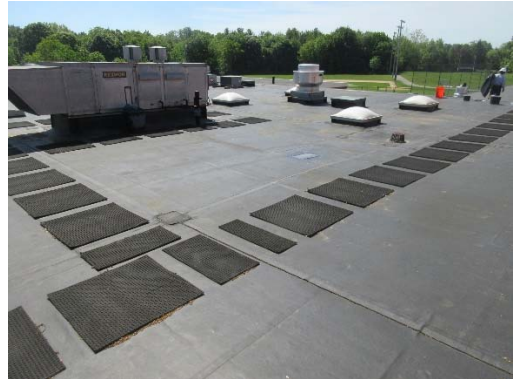
Kitchen Exhaust

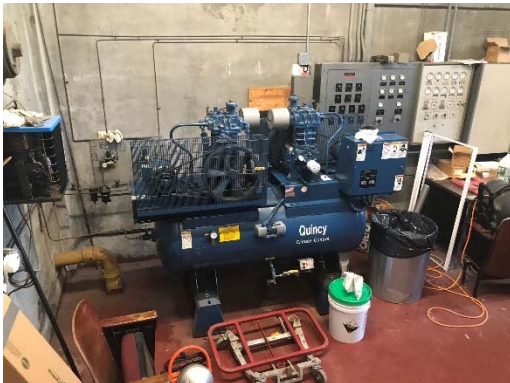
The building controls are pneumatic with the air compressor located within the mechanical room. Pneumatic tubing extends from the mechanical room to controllers throughout the building.

Air Compressor

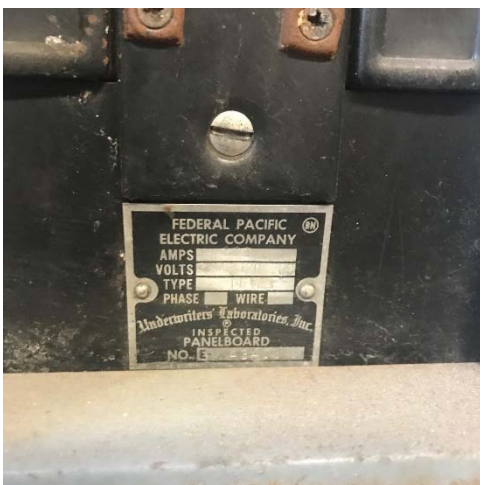
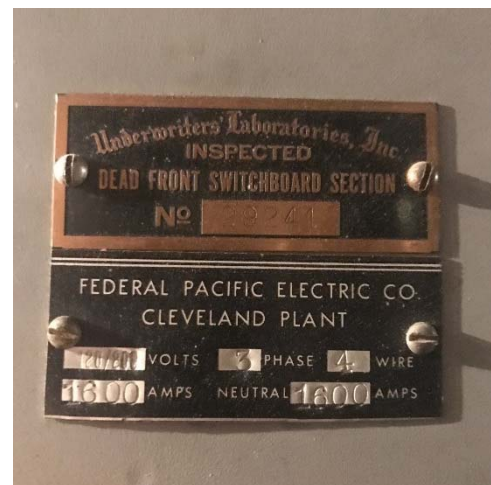
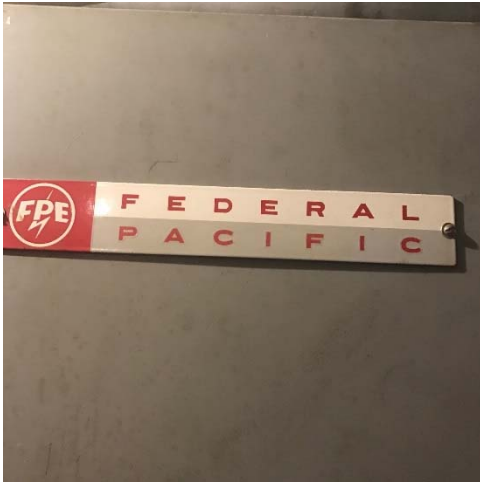
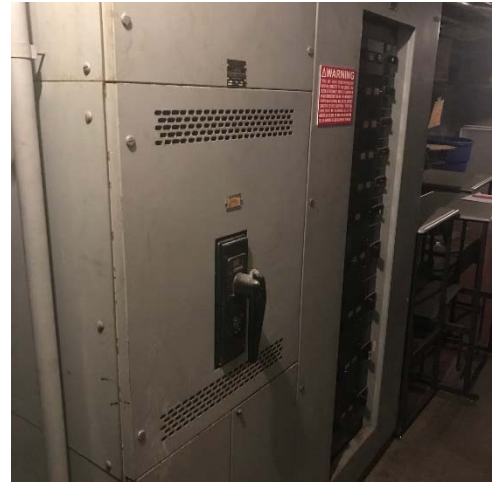
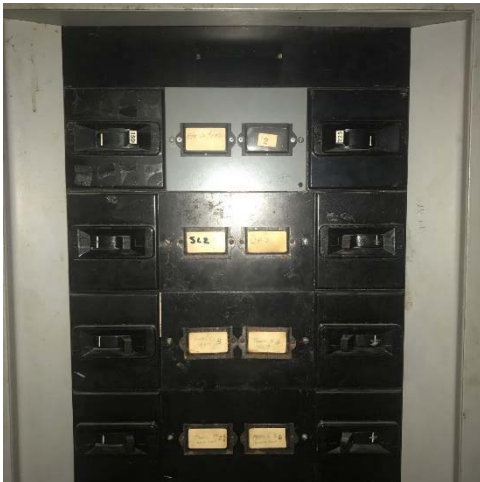
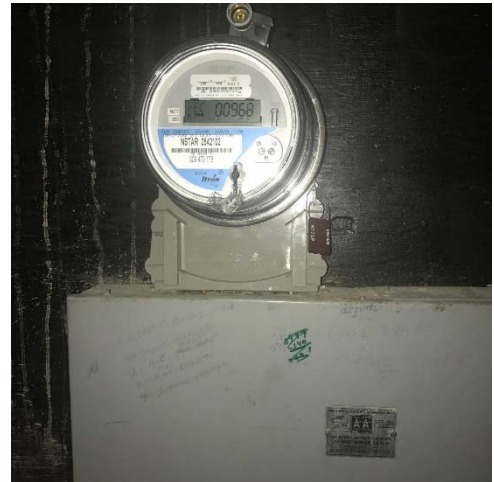
The manufacturer of the gear, Federal Pacific Electric, has not been in business for over 30 years. Spare or replacement parts for F.P.E. gear is virtually non-existent or very expensive to purchase.

Past utility records (from the previous 12 months) indicate that the largest demand on the electric service is 140.4 KVA, which equates to 390 amps at 120/208 volt 3-phase. Therefore, theoretically there is a spare amount of 890 amps on the existing electric service that could be utilized for the proposed added HVAC equipment (details in other section of this report). (1600 amps X 80% Rated Breaker -390 AMPS = 890 amps). If Option #2 is to be considered, that would add an approximate 1,263 amps of mechanical load. The existing electrical service would not be able to support that added load.

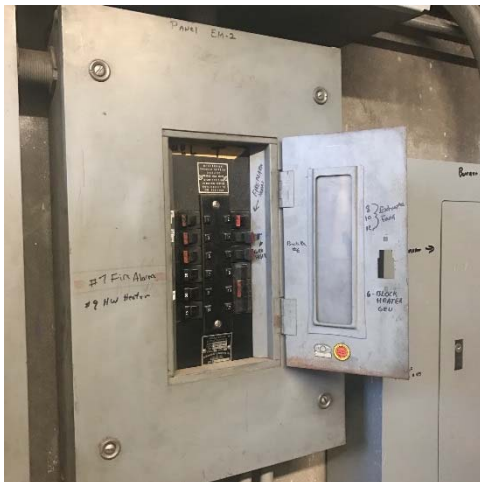
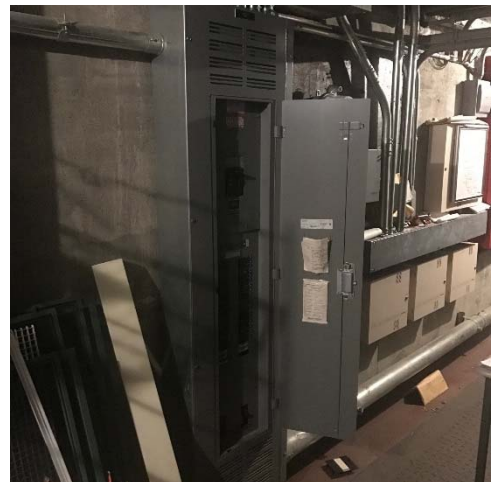
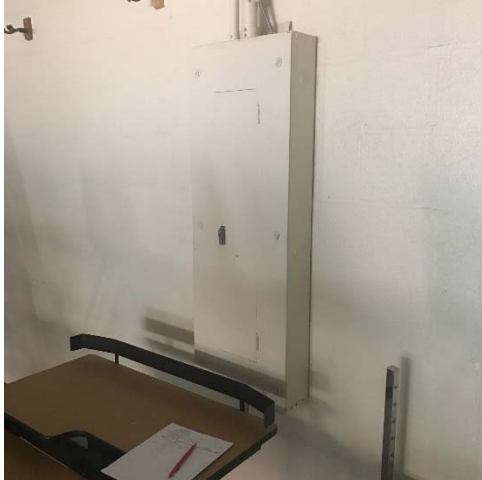
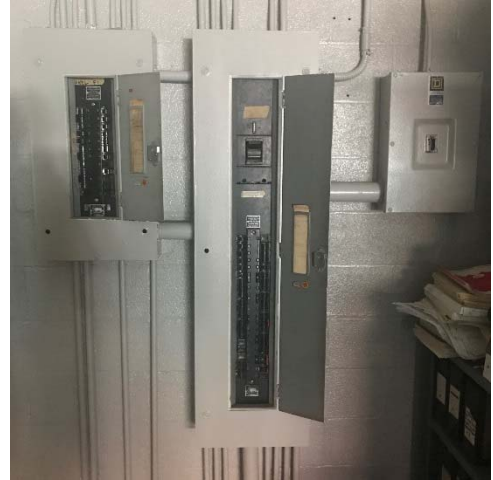
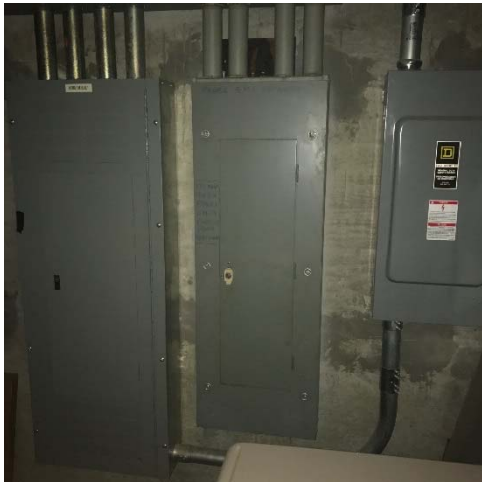
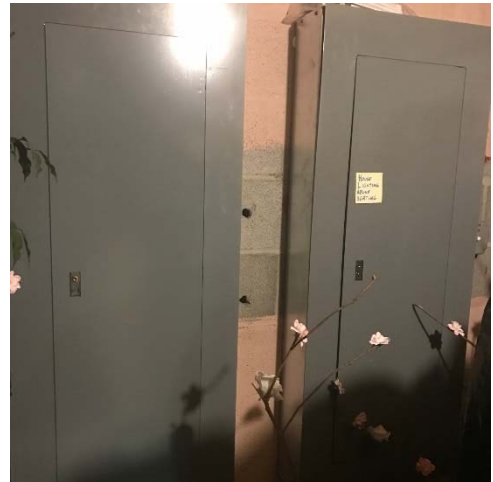
The janitor panels are within 6' of the existing slop/ janitor sink. The installation would not meet the latest NEC for clearances around sinks.

The corridor panels contain split busses. They are fed from both a normal circuit and also from an emergency circuit. The top one half of the circuit breakers feed normal power loads. The bottom half feed emergency lighting and exit signs. This type of panel is no longer allowable by the latest version of the NEC.

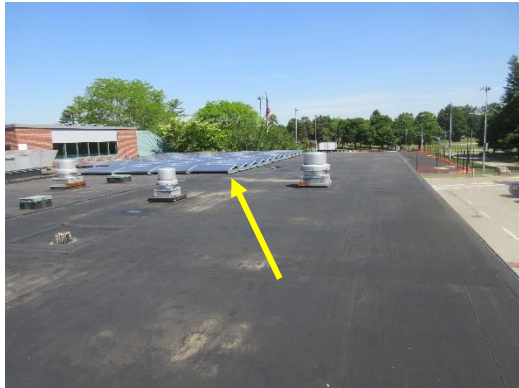
<p>Partial view of Roof Areas A & A.1. Notice Photovoltaic (PV) Solar Panels located on Roof Area A.</p>
2

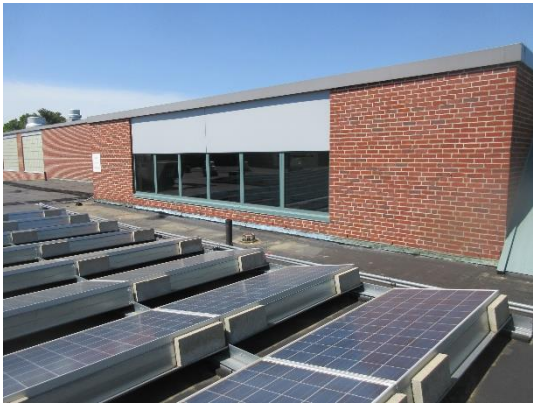
<p>Partial view of Roof Area A, covered with PV panels and adjoining brick masonry wall</p>
3

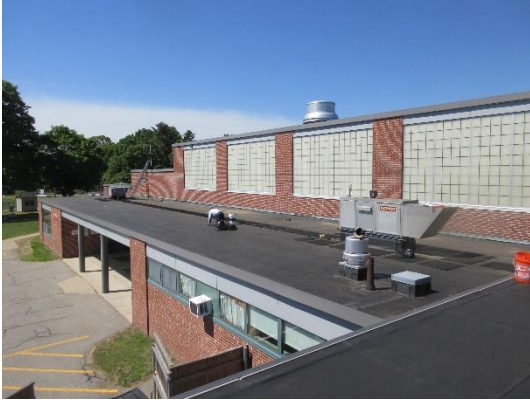
Overall view of Roof Area B.
2

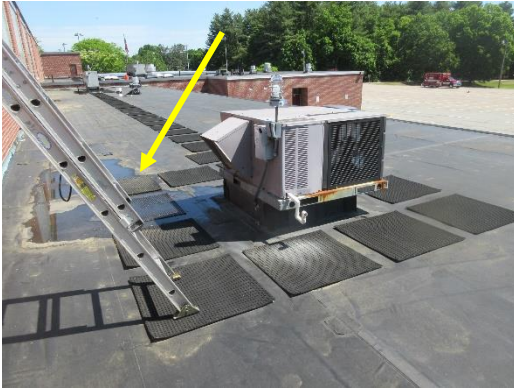
Another view of Roof Area B, toward Roof Area A/A.1. Notice rooftop equipment and ponding water.
3

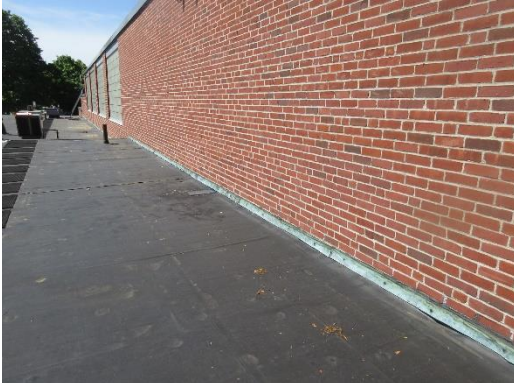
Partial view of Roof Area B, along higher brick masonry wall and copper through-wall counterflashing.

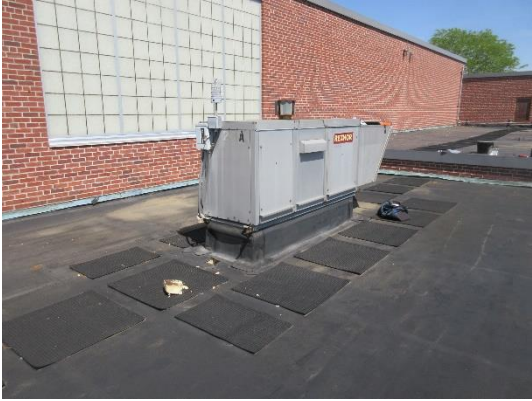
View of rooftop HVAC unit.
5

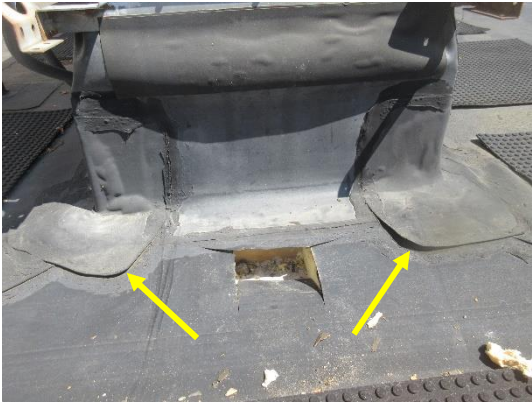
Open laps at HVAC unit curb flashing.
6

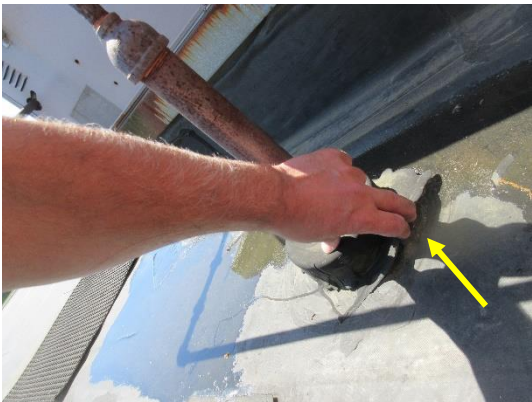
Open lap at pitch pocket flashing, adjacent RTU.

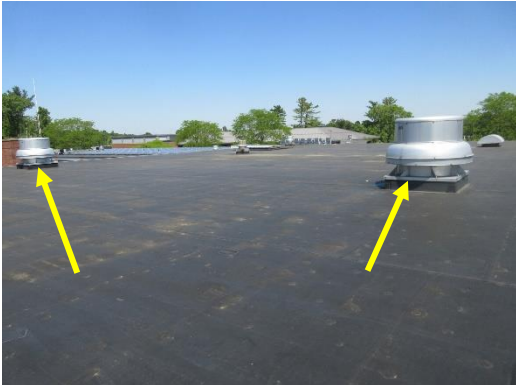
Overall view of Roof Area C, which includes large exhaust fans.
2

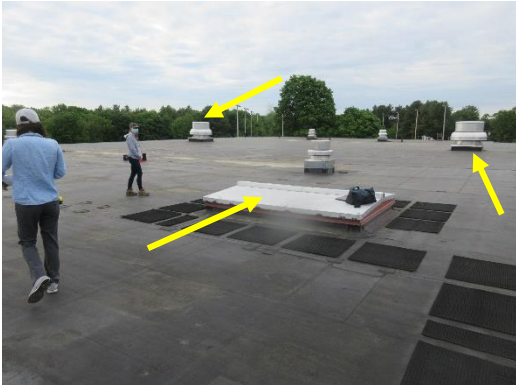
Partial view of Roof Area C, which includes smoke hatch and exhaust fans.
3

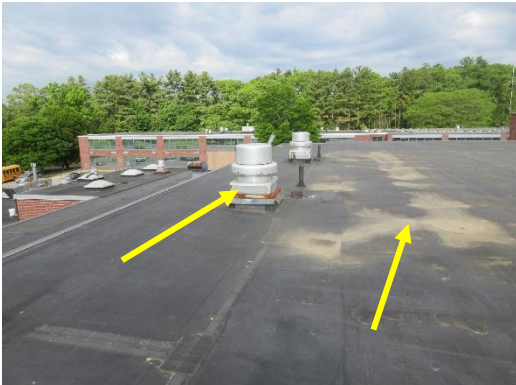
Partial view of Roof Area with exhaust vents and vent pipes. Notice the remanence of ponding water with dirt residue.

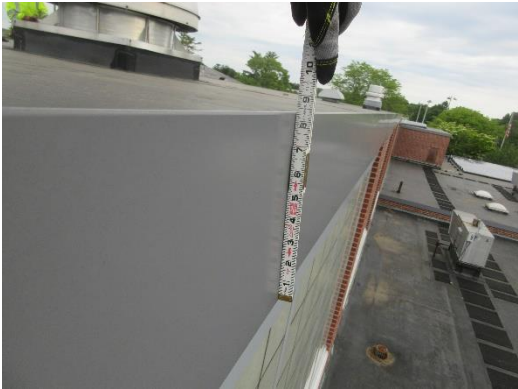
Typical perimeter edge metal fascia.
5

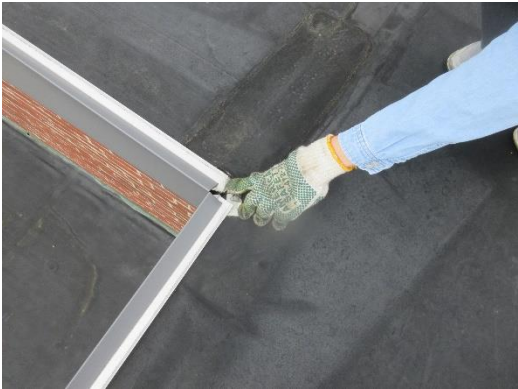
View a gap between roofing membrane and edge metal flashing.
6

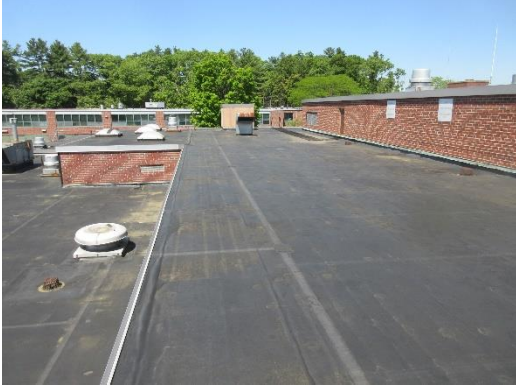
A wide-angle photograph of a flat roof area. The roof is dark grey/black with a white circular vent in the foreground. A brick wall runs along the right side, and trees are visible in the background under a clear blue sky.	Overall view of Roof Area D.
2

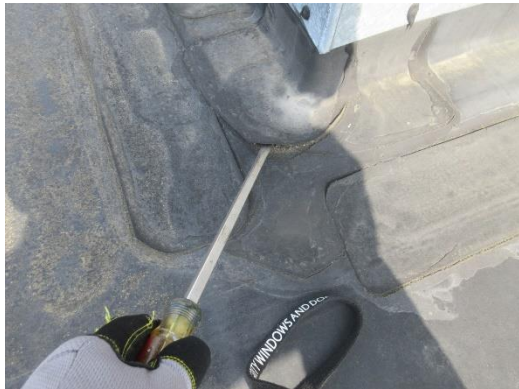
View of open membrane flashing lap seam at exhaust fan curb.
4

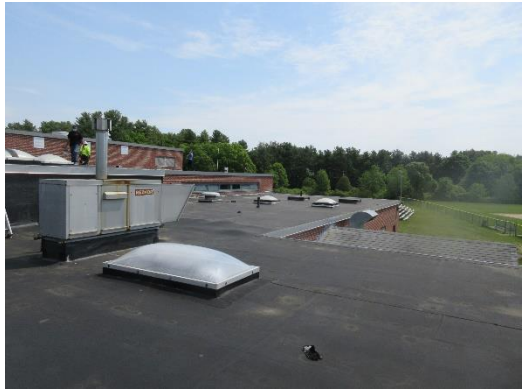
Overall view of Roof Area D.1, including RTU and skylight
2

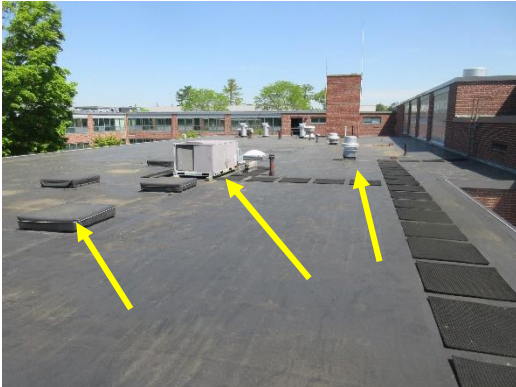
Overall view of Roof Area E, with covered abandoned curbs, RTU unit and exhaust fans.
2

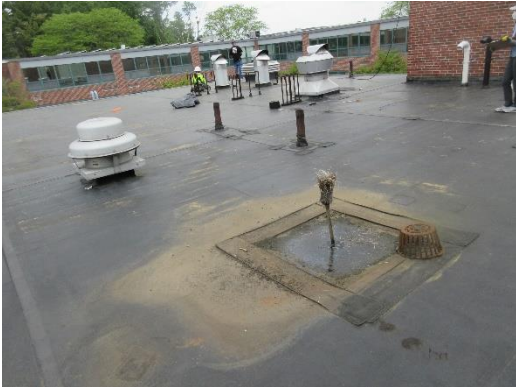
View of clogged roof drain, and sump.
3

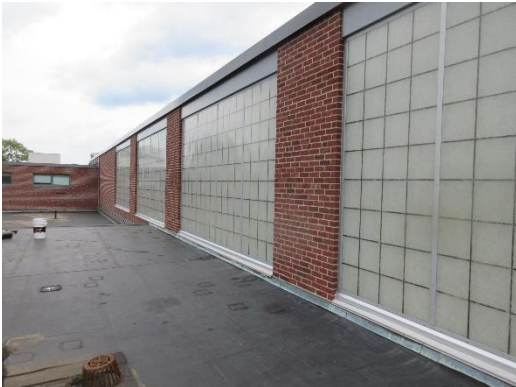
View of translucent insulated wall panels of the Gymnasium, and counterflashing detail below.

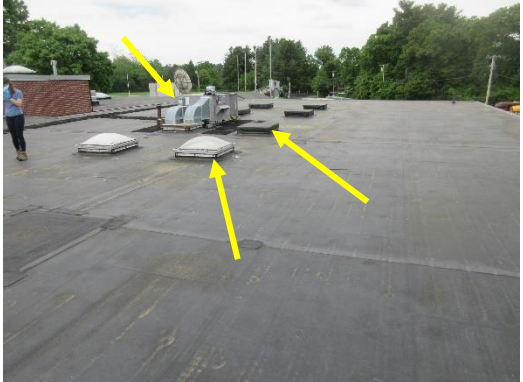
Partial view of Roof Area E, with covered abandoned curbs, RTU unit and skylights.
5

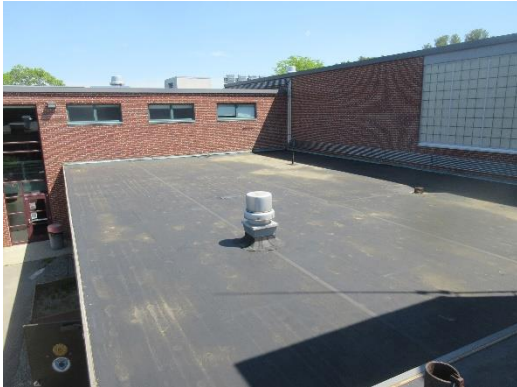
Overall view of Roof Area F.
2

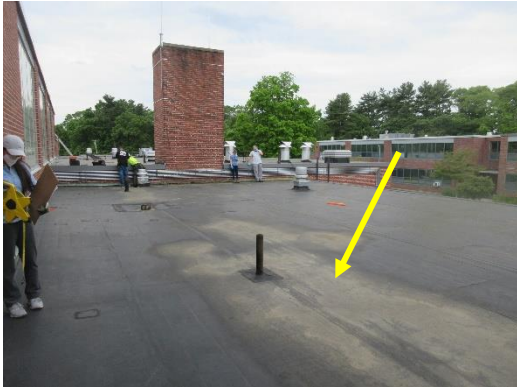
Partial view of Roof Area F. Notice the remanence of ponding water with dirt residue.
3

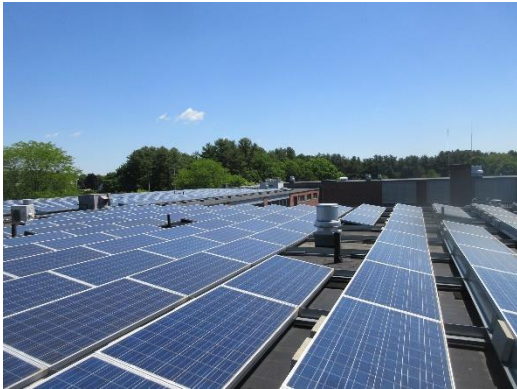
<p>Partial view of Roof Area G, covered with PV solar panels</p>
2

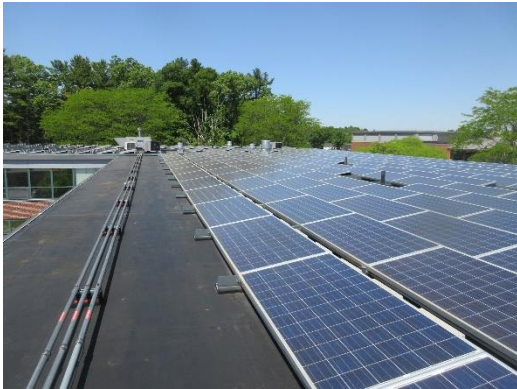
<p>Another partial view of Roof Area G, covered with PV solar panels.</p>
3

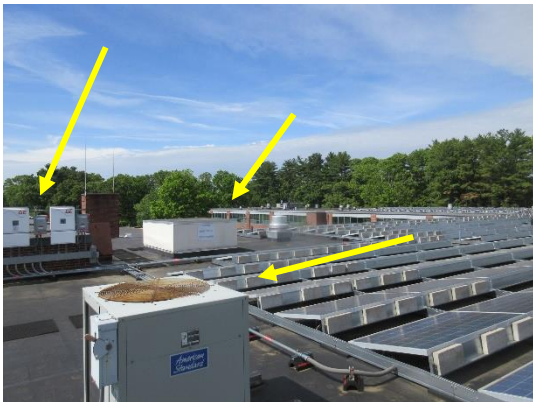
<p>View of elevator override, PV power panels and A/C condenser unit.</p>

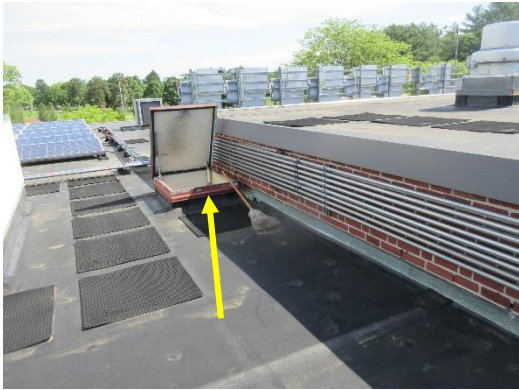
<p>4</p>

<p>View of roof access hatch and conduit apply to existing brick masonry wall.</p>
<p>5</p>

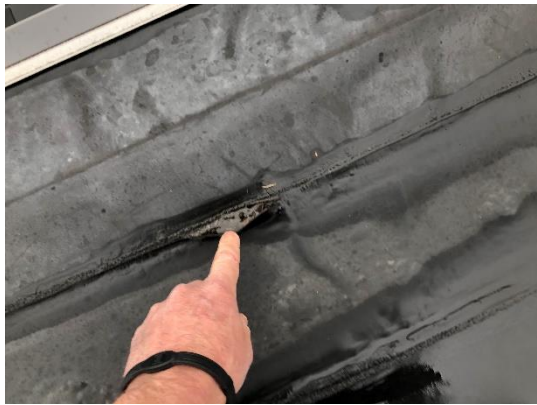
<p>7</p>

<p>View of open seam lap adjacent to roof edge.</p>
<p>8</p>

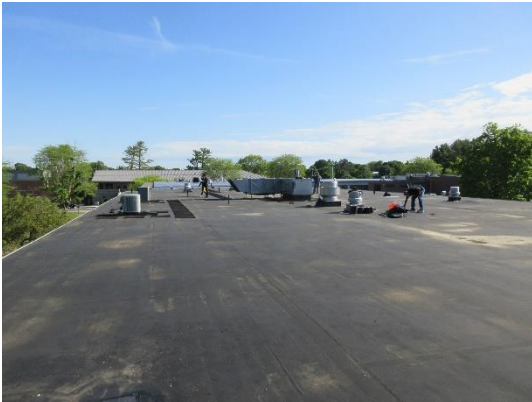
Photo No.		Description
1

<p>Partial view of Roof Area H.</p>
2

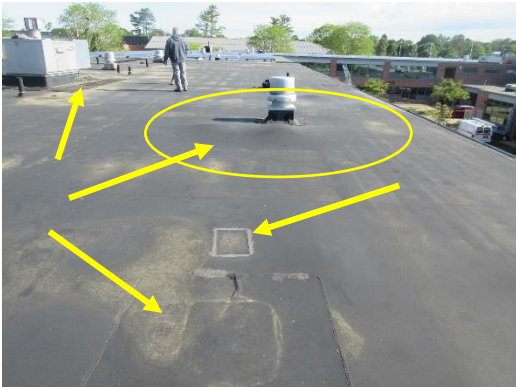
<p>Another partial view of Roof Area H. Notice prior patches and buckled insulation below the membrane surface, and the remanence of ponding water with dirt residue.</p>
3

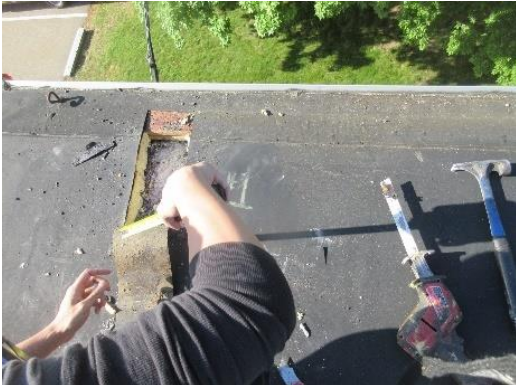
Photo No.		Description
1

Test Cut #1-Roof H - EPDM Membrane - 2.25" Polyisocyanurate - 5-Ply Gravel Surface BUR
2

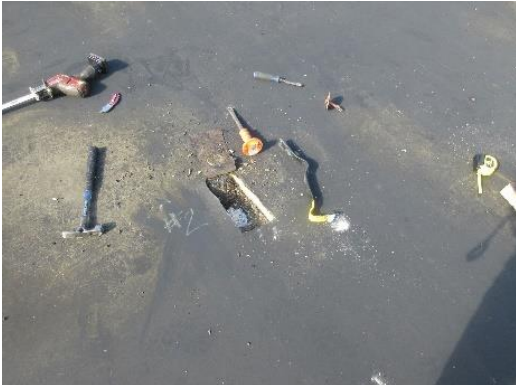
Test Cut #2 -Roof H - EPDM Membrane - 2.25" Polyisocyanurate - 5-Ply Gravel Surface BUR
3

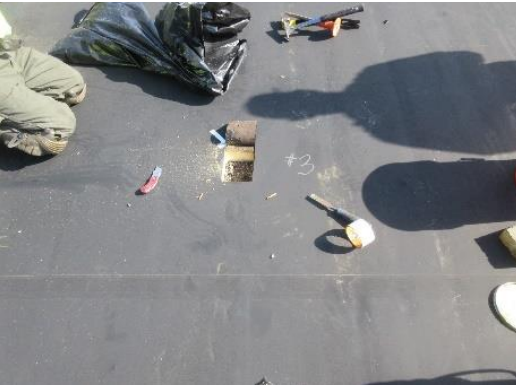
Test Cut #3 -Roof H - EPDM Membrane - 2.25" Polyisocyanurate - 5-Ply Gravel Surface BUR

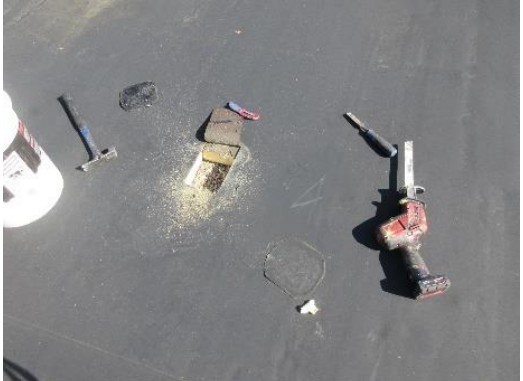
<p>4</p>

<p>Test Cut #4 -Roof H - EPDM Membrane - 2.25" Polyisocyanurate - 5-Ply Gravel Surface BUR</p>
<p>5</p>

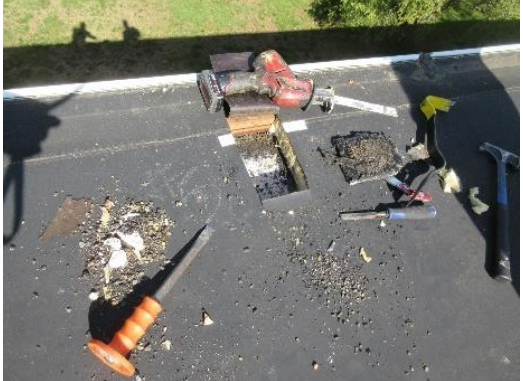
<p>Test Cut #5 -Roof H - EPDM Membrane - 2.25" Polyisocyanurate - 5-Ply Gravel Surface BUR</p>
<p>6</p>

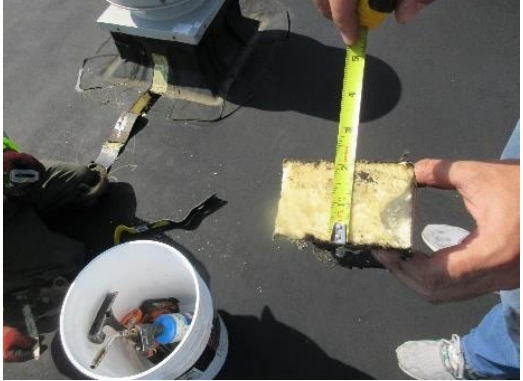
<p>Test Cut #6 -Roof H - EPDM Membrane - 2.25" Polyisocyanurate - 5-Ply Gravel Surface BUR</p>

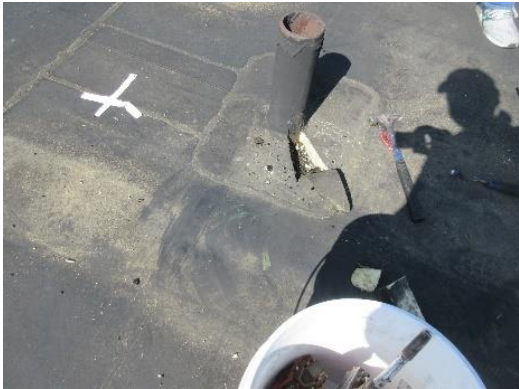
<p>7</p>

<p>Test Cut #7 -Roof H - EPDM Membrane - 2.25" Polyisocyanurate - 5-Ply Gravel Surface BUR</p>
<p>8</p>

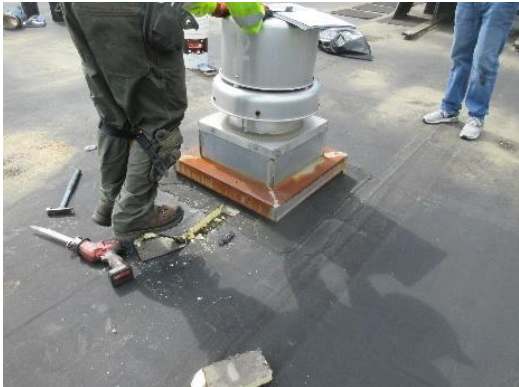
<p>Test Cut #8 -Roof H - EPDM Membrane - 2.25" Polyisocyanurate - 5-Ply Gravel Surface BUR</p>
<p>9</p>

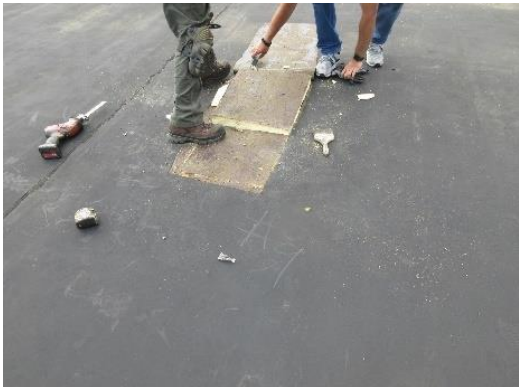
<p>Test Cut #9 -Roof H - EPDM Membrane - 2.25" Polyisocyanurate - 5-Ply Gravel Surface BUR</p>

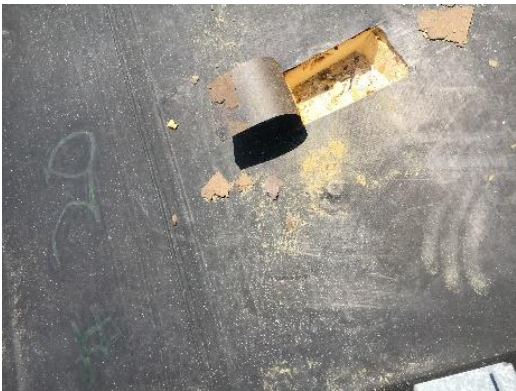
Test Cut #20 -Roof G - EPDM Membrane - 2.75" Polyisocyanurate
21

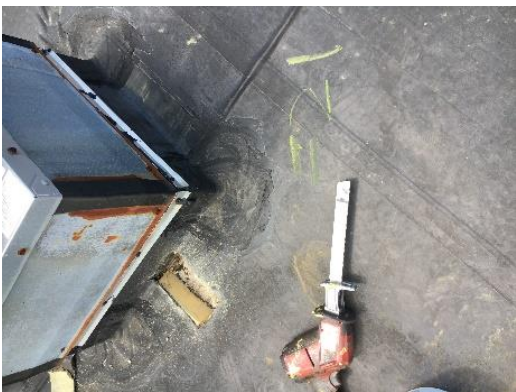
Test Cut #21 -Roof G - EPDM Membrane - 2.75" Polyisocyanurate

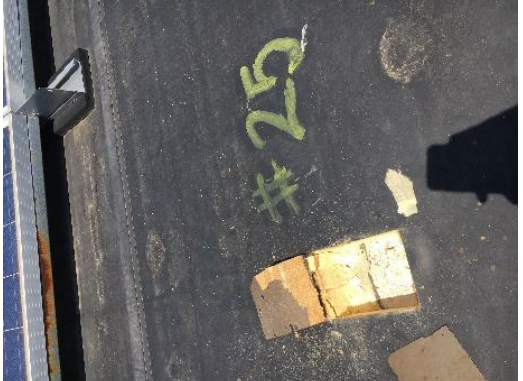
<p>25</p>

<p>Test Cut #25 -Roof G - EPDM Membrane - 2.75" Polyisocyanurate</p>
<p>26</p>

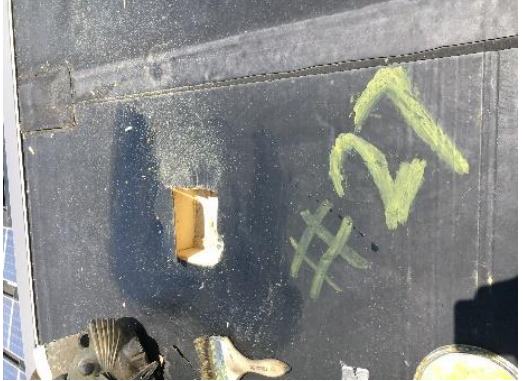
<p>Test Cut #27 -Roof G - EPDM Membrane - 2.75" Polyisocyanurate</p>

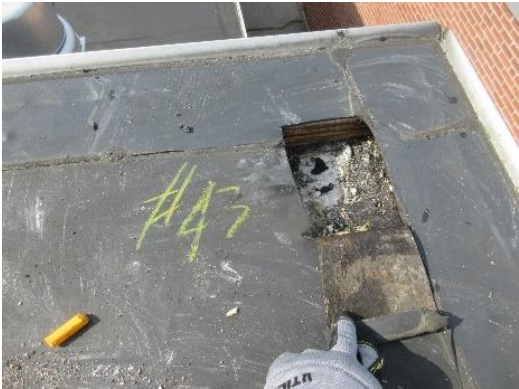
<p>43</p>

<p>Test Cut #43 -Roof D - EPDM Membrane - 2.75" Polyisocyanurate</p>
<p>44</p>

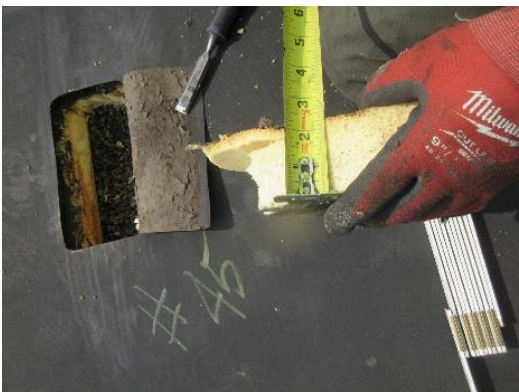
<p>Test Cut #45 -Roof D - EPDM Membrane - 2.25" Polyisocyanurate - 5-Ply Gravel Surface BUR</p>

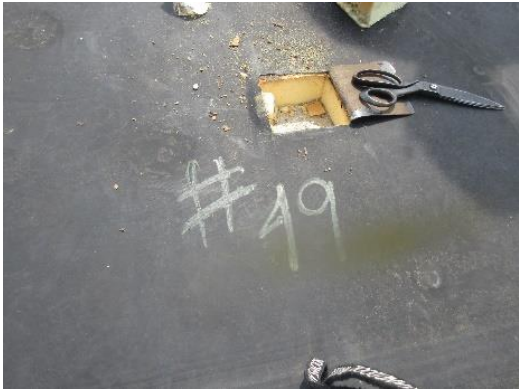
<p>49</p>

<p>Test Cut #49 -Roof D - EPDM Membrane - 2.75" Polyisocyanurate - 5-Ply Gravel Surface BUR</p>
<p>50</p>

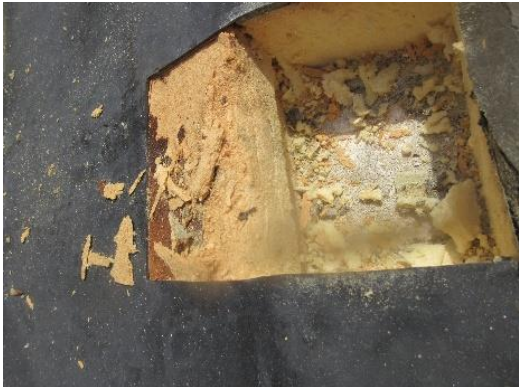
<p>Test Cut #50 -Roof D - EPDM Membrane - 2.75" Polyisocyanurate - 5-Ply Gravel Surface BUR</p>
<p>51</p>

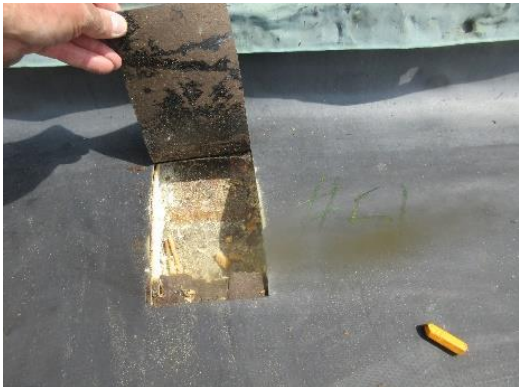
<p>Test Cut #51 -Roof D - EPDM Membrane - 2.75" Polyisocyanurate - 5-Ply Gravel Surface BUR</p>

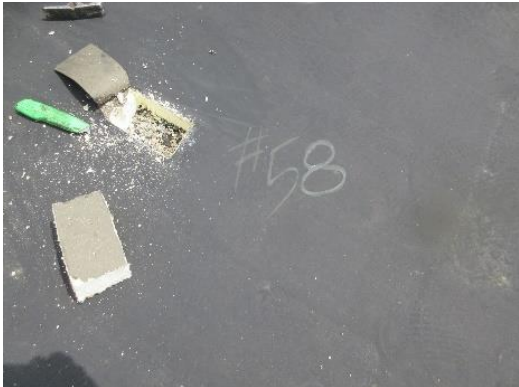
<p>58</p>

<p>Test Cut #58 -Roof D.1 - EPDM Membrane - 2.25" Polyisocyanurate - 5-Ply Gravel Surface BUR</p>
<p>59</p>

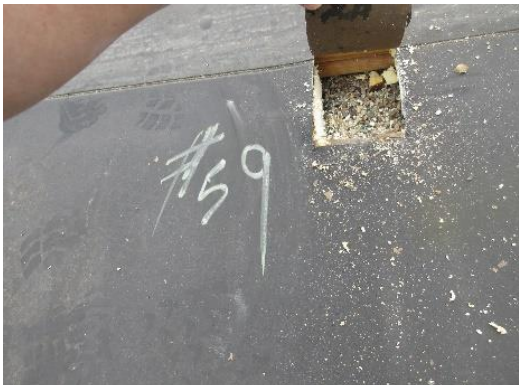
<p>Test Cut #59 -Roof D.1 - EPDM Membrane - 2.25" Polyisocyanurate - 5-Ply Gravel Surface BUR</p>
<p>60</p>

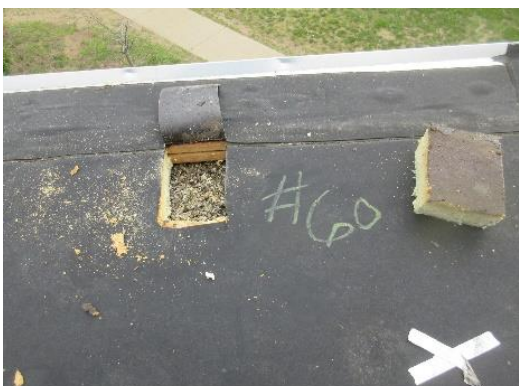
<p>Test Cut #60 -Roof D.1 - EPDM Membrane - 2.5" Polyisocyanurate - 5-Ply Gravel Surface BUR</p>

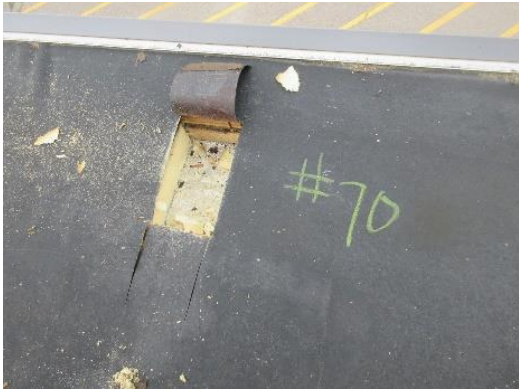
<p>70</p>

<p>Test Cut #70 -Roof E - EPDM Membrane - 2.75" Polyisocyanurate - 5-Ply Gravel Surface BUR</p>
<p>71</p>

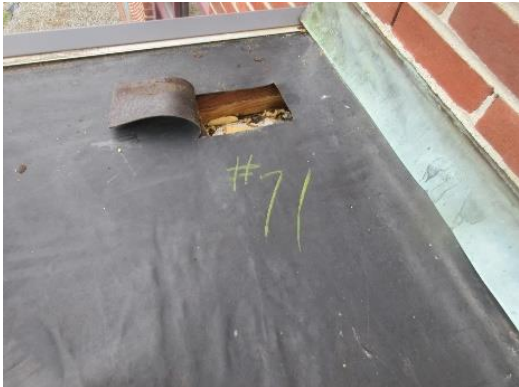
<p>Test Cut #71 -Roof F - EPDM Membrane - 2.75" Polyisocyanurate - 5-Ply Gravel Surface BUR</p>
<p>72</p>

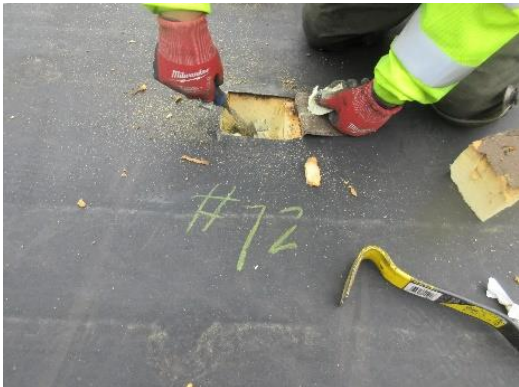
<p>Test Cut #72 -Roof F - EPDM Membrane - 2.75" Polyisocyanurate - 5-Ply Gravel Surface BUR</p>

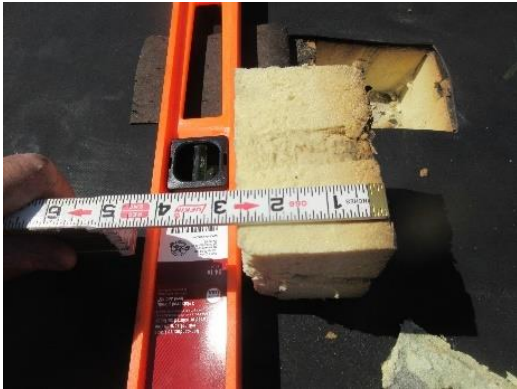
<p>82</p>

<p>Test Cut #82 -Roof A - EPDM Membrane - 2.75" Polyisocyanurate</p>
<p>83</p>

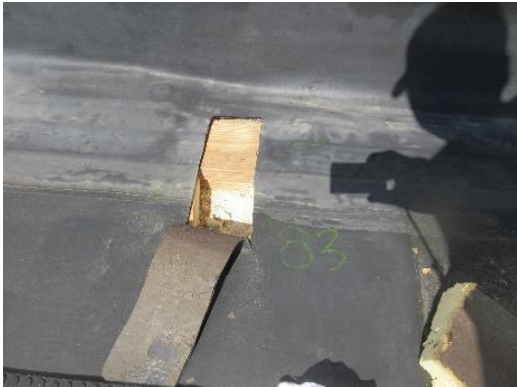
<p>Test Cut #83 -Roof A - EPDM Membrane - 2.75" Polyisocyanurate</p>
<p>84</p>

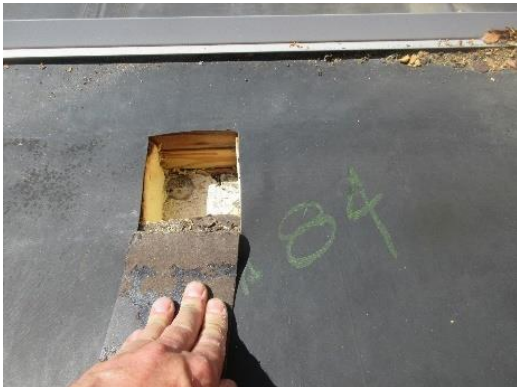
<p>Test Cut #84 -Roof A - EPDM Membrane - 2.75" Polyisocyanurate</p>

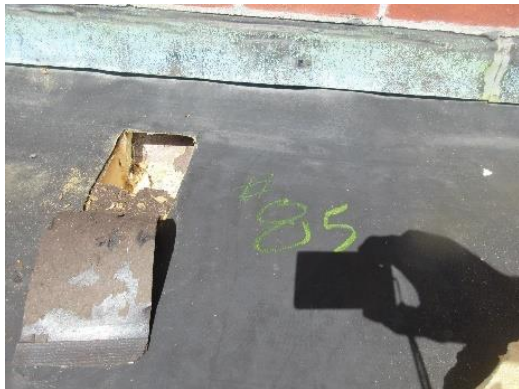
<p>85</p>

<p>Test Cut #85 -Roof A - EPDM Membrane - 2.75" Polyisocyanurate</p>
<p>86</p>

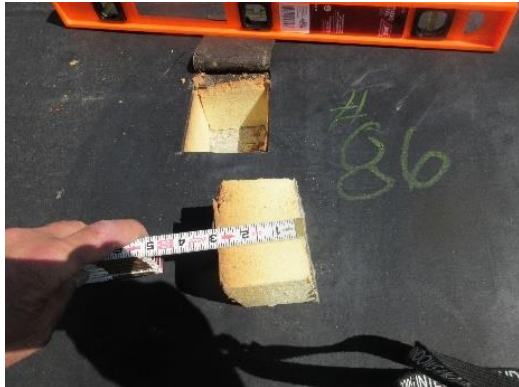
<p>Test Cut #86 -Roof A - EPDM Membrane - 2.75" Polyisocyanurate</p>
<p>87</p>

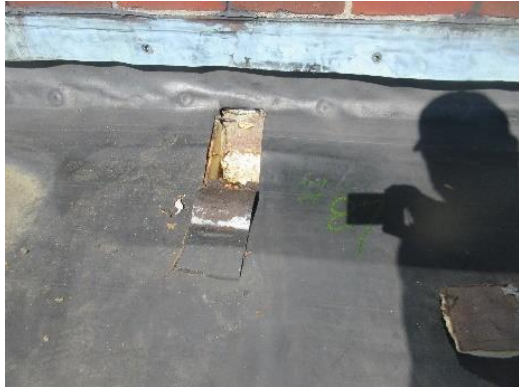
<p>Test Cut #87 -Roof A - EPDM Membrane - 2.75" Polyisocyanurate</p>

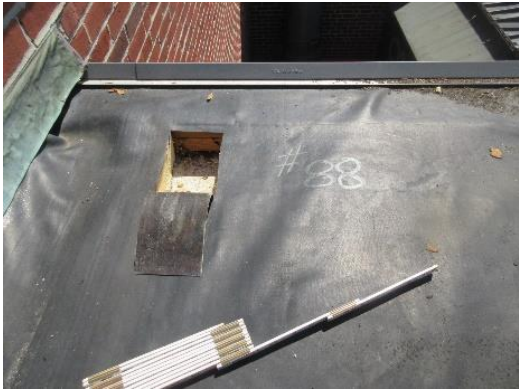
<p>Test Cut #88 -Roof B - EPDM Membrane - 2.75" Polyisocyanurate</p>
<p>89</p>

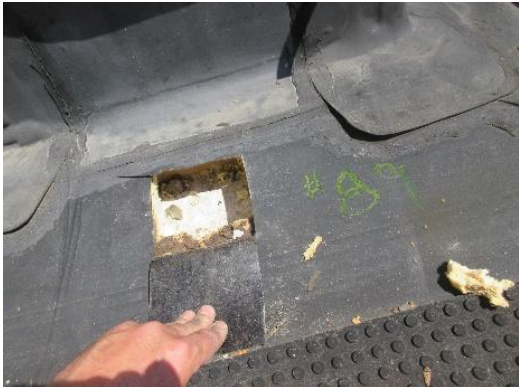
<p>Test Cut #89 -Roof B - EPDM Membrane - 2.75" Polyisocyanurate</p>
<p>90</p>

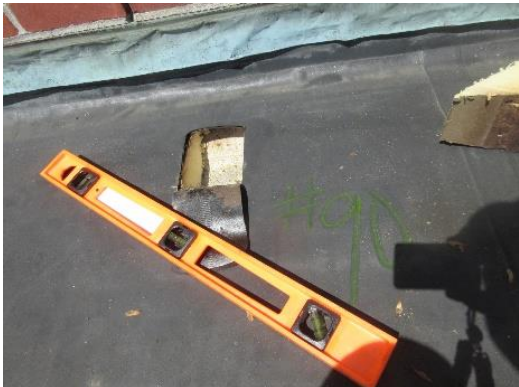
<p>Test Cut #90 -Roof B - EPDM Membrane - 2.75" Polyisocyanurate</p>

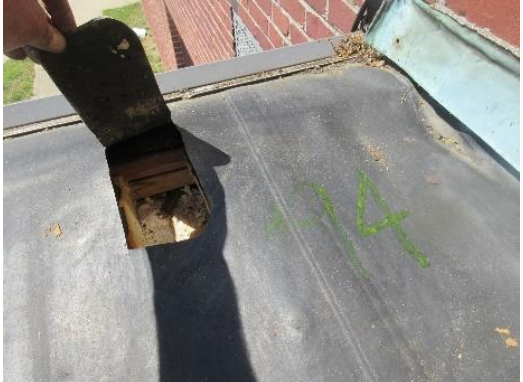
94

Test Cut #94 -Roof B - EPDM Membrane - 2.75" Polyisocyanurate
----	--	---
